## AN INVESTIGATION OF LOW-CYCLE FATIGUE FAILURES USING APPLIED FRACTURE MECHANICS

TECHNICAL DOCUMENTARY REPORT ML-TDR-64-53 MAY 1964

AIR FORCE MATERIALS LABORATORY
RESEARCH AND TECHNOLOGY DIVISION
AIR FORCE SYSTEMS COMMAND
WRIGHT-PATTERSON AIR FORCE BASE, OHIO

(Prepared under Contract AF 33(657)-10251 by The Boeing Company, Aero-Space Division, Seattle, Washington 98124; C. F. Tiffany and P. M. Lorenz, authors)

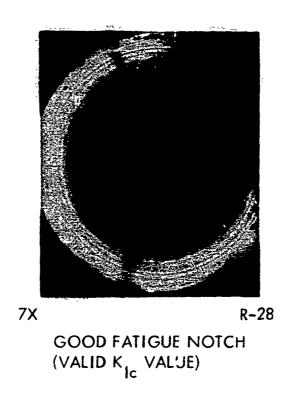
Figure 35: Sample Fractographs of Ladish D6A-C Sharply Notched Round Bar Specimens (Static Test)

Sample fractographs of sharply notched round bar specimens tested under static and cyclic loading conditions are shown in Figures 35 and 36, respectively. Sample fractographs of surface-flawed specimens are shown in Figure 37 in Appendix IV. Figures 35 and 36 illustrate some of the flaw growth irregularities encountered during cyclic testing of Ladish D6A-C sharply notched round bar specimens.

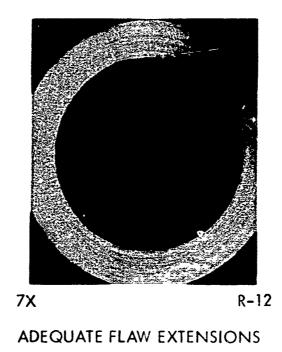
Figure 36: Sample Fractographs of Ladish D6A-C Steel Sharply Notched Round Bar Specimens (Cyclic Test)

ECCENTRIC INITIAL AND FINAL CYCLIC FLAW EXTENSIONS

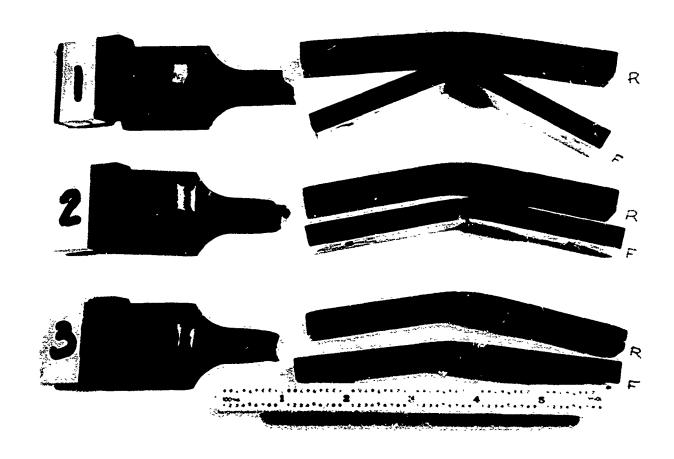
Figure 38: Tensile and Bend Weld Point Specimens of Ladish D6A-C Weld

Test results on the effect of moisture and variation of heat treatment cycles (normalized versus non-normalized specimens) are listed in Table 7. Tensile and bend test data of Ladish D6A-C weld test panels are listed in Table 8. General appearance of the tensile and bend weld joint test specimens after testing is shown in Figure 38.

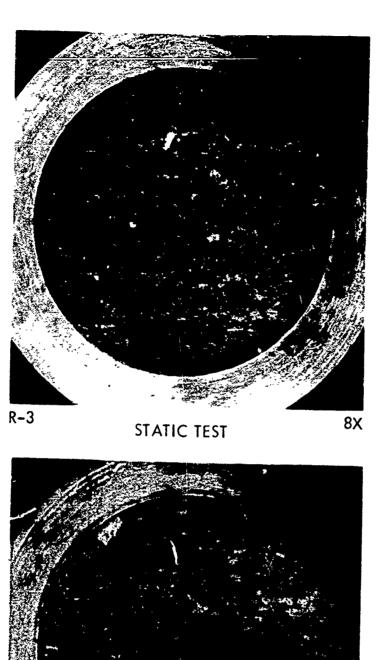
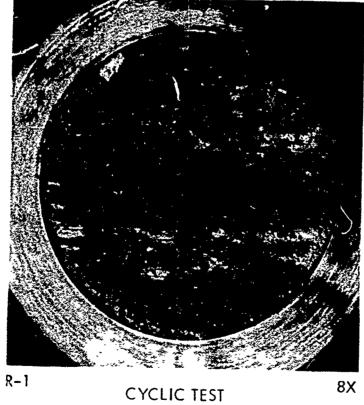
Figure 45: Sample Fractographs of 6AI-4V Titanium Sharply Notched Round Bar Specimens

Tensile properties of the 6Al-4V titanium tested at -320°F in the environmen of liquid nitrogen are listed in Table 10. Static fracture toughness and cyclic flaw growth data obtained using sharply notched round bar specimens were calculated using planimeter technique and are listed in Table 11. Figure 1° snows a plot of static fracture toughness for annealed 6Al-4V titanium as a function of test temperature. Test data at other than -320°F temperature was obtained in connection with other Boeing programs. Sample fractographs of sharply notched 6Al-4V titanium specimens tested at -320°F are shown in Figure 45.

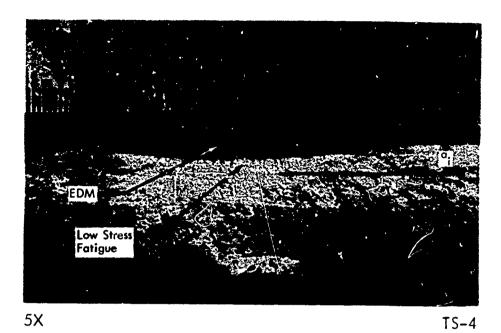
Figure 46: Sample Fractographs of 6AI-4V Titanium Surface-Flawed Specimens

Cyclic flaw growth data obtained using surface flawed 6Al-4V titanium specimens are listed in Table 12. Figure 46 in Appendix IV shows sample fractographs of 6Al-4V titanium surface flawed specimen tested at -320°F. General appearance of the fractured 6Al-4V titanium surface flawed specimens is shown in Figure 47.

Consider now a relatively shallow surface flaw, such as that shown in Figure 46 for Specimen TS=3. Since the differences in stress intensity, K, at the exposed corners of the surface flaw and at its deepest point are large, the flaw, under cyclic loading, would be expected to propagate in depth, with very little growth along the surface. This will continue until the depth-to-length ratio increases, giving a higher K value at the corners (note the increase of K at the corners between flaws, with a/2c ratios of 0.10, 0.20, and 0.30 in Figure 20). At this point the flaw growth will be somewhat equalized along the entire periphery although the tendency to grow faster in depth continues to prevail until a completely circular shape and an even stress distribution along the flaw periphery are achieved.

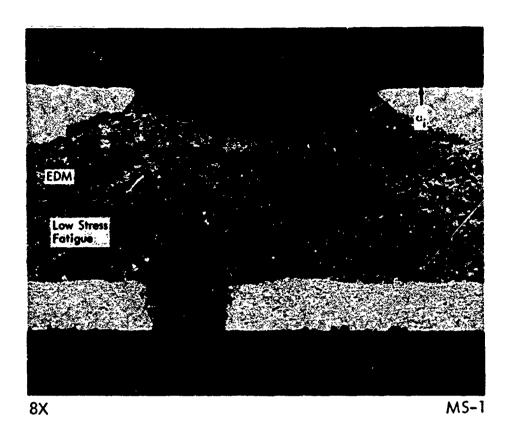
Figure 49: Sample Fractographs of Surface-Flawed 18 Ni(300)
Maraging Steel Specimens

Static fracture toughness and cyclic flaw growth data of 15Ni(300) maraging steel tested at room temperature using surface-flawed specimens were calculated using previously described planimeter technique and are listed in Table 15. The MS-1 specimen failed in grip area at 247.0 ksi during static test. The MS-2 specimen failed in grip during cyclic test at the end of 1396 cycles. Both specimens were remachined to 3.5-inch widths and tested. The MS-1 specimen was pulled to failure at a fracture stress of 257.4 ksi. Cyclic testing at 112.6 ksi of the MS-2 specimen was resumed and continued for an additional 2514 cycles until the flaw grew through the thickness. The specimen was then pulled to a failure at a fracture stress of 119.2 ksi. Specimens MC-5 and MC-8 were machined to 3.5-inch widths, then tested. Figures 49 and 50 show sample fractographs of statically and cyclically tested 18Ni(300) surface flawed specimens, respectively.
